## Memorandum

Subject: Summary of Creek Investigations Completed for Libby Asbestos  
Superfund Site Operable Units 4 and 7, October 2008

OU4 Creek Investigations  
Libby Asbestos Site  
Libby, Montana

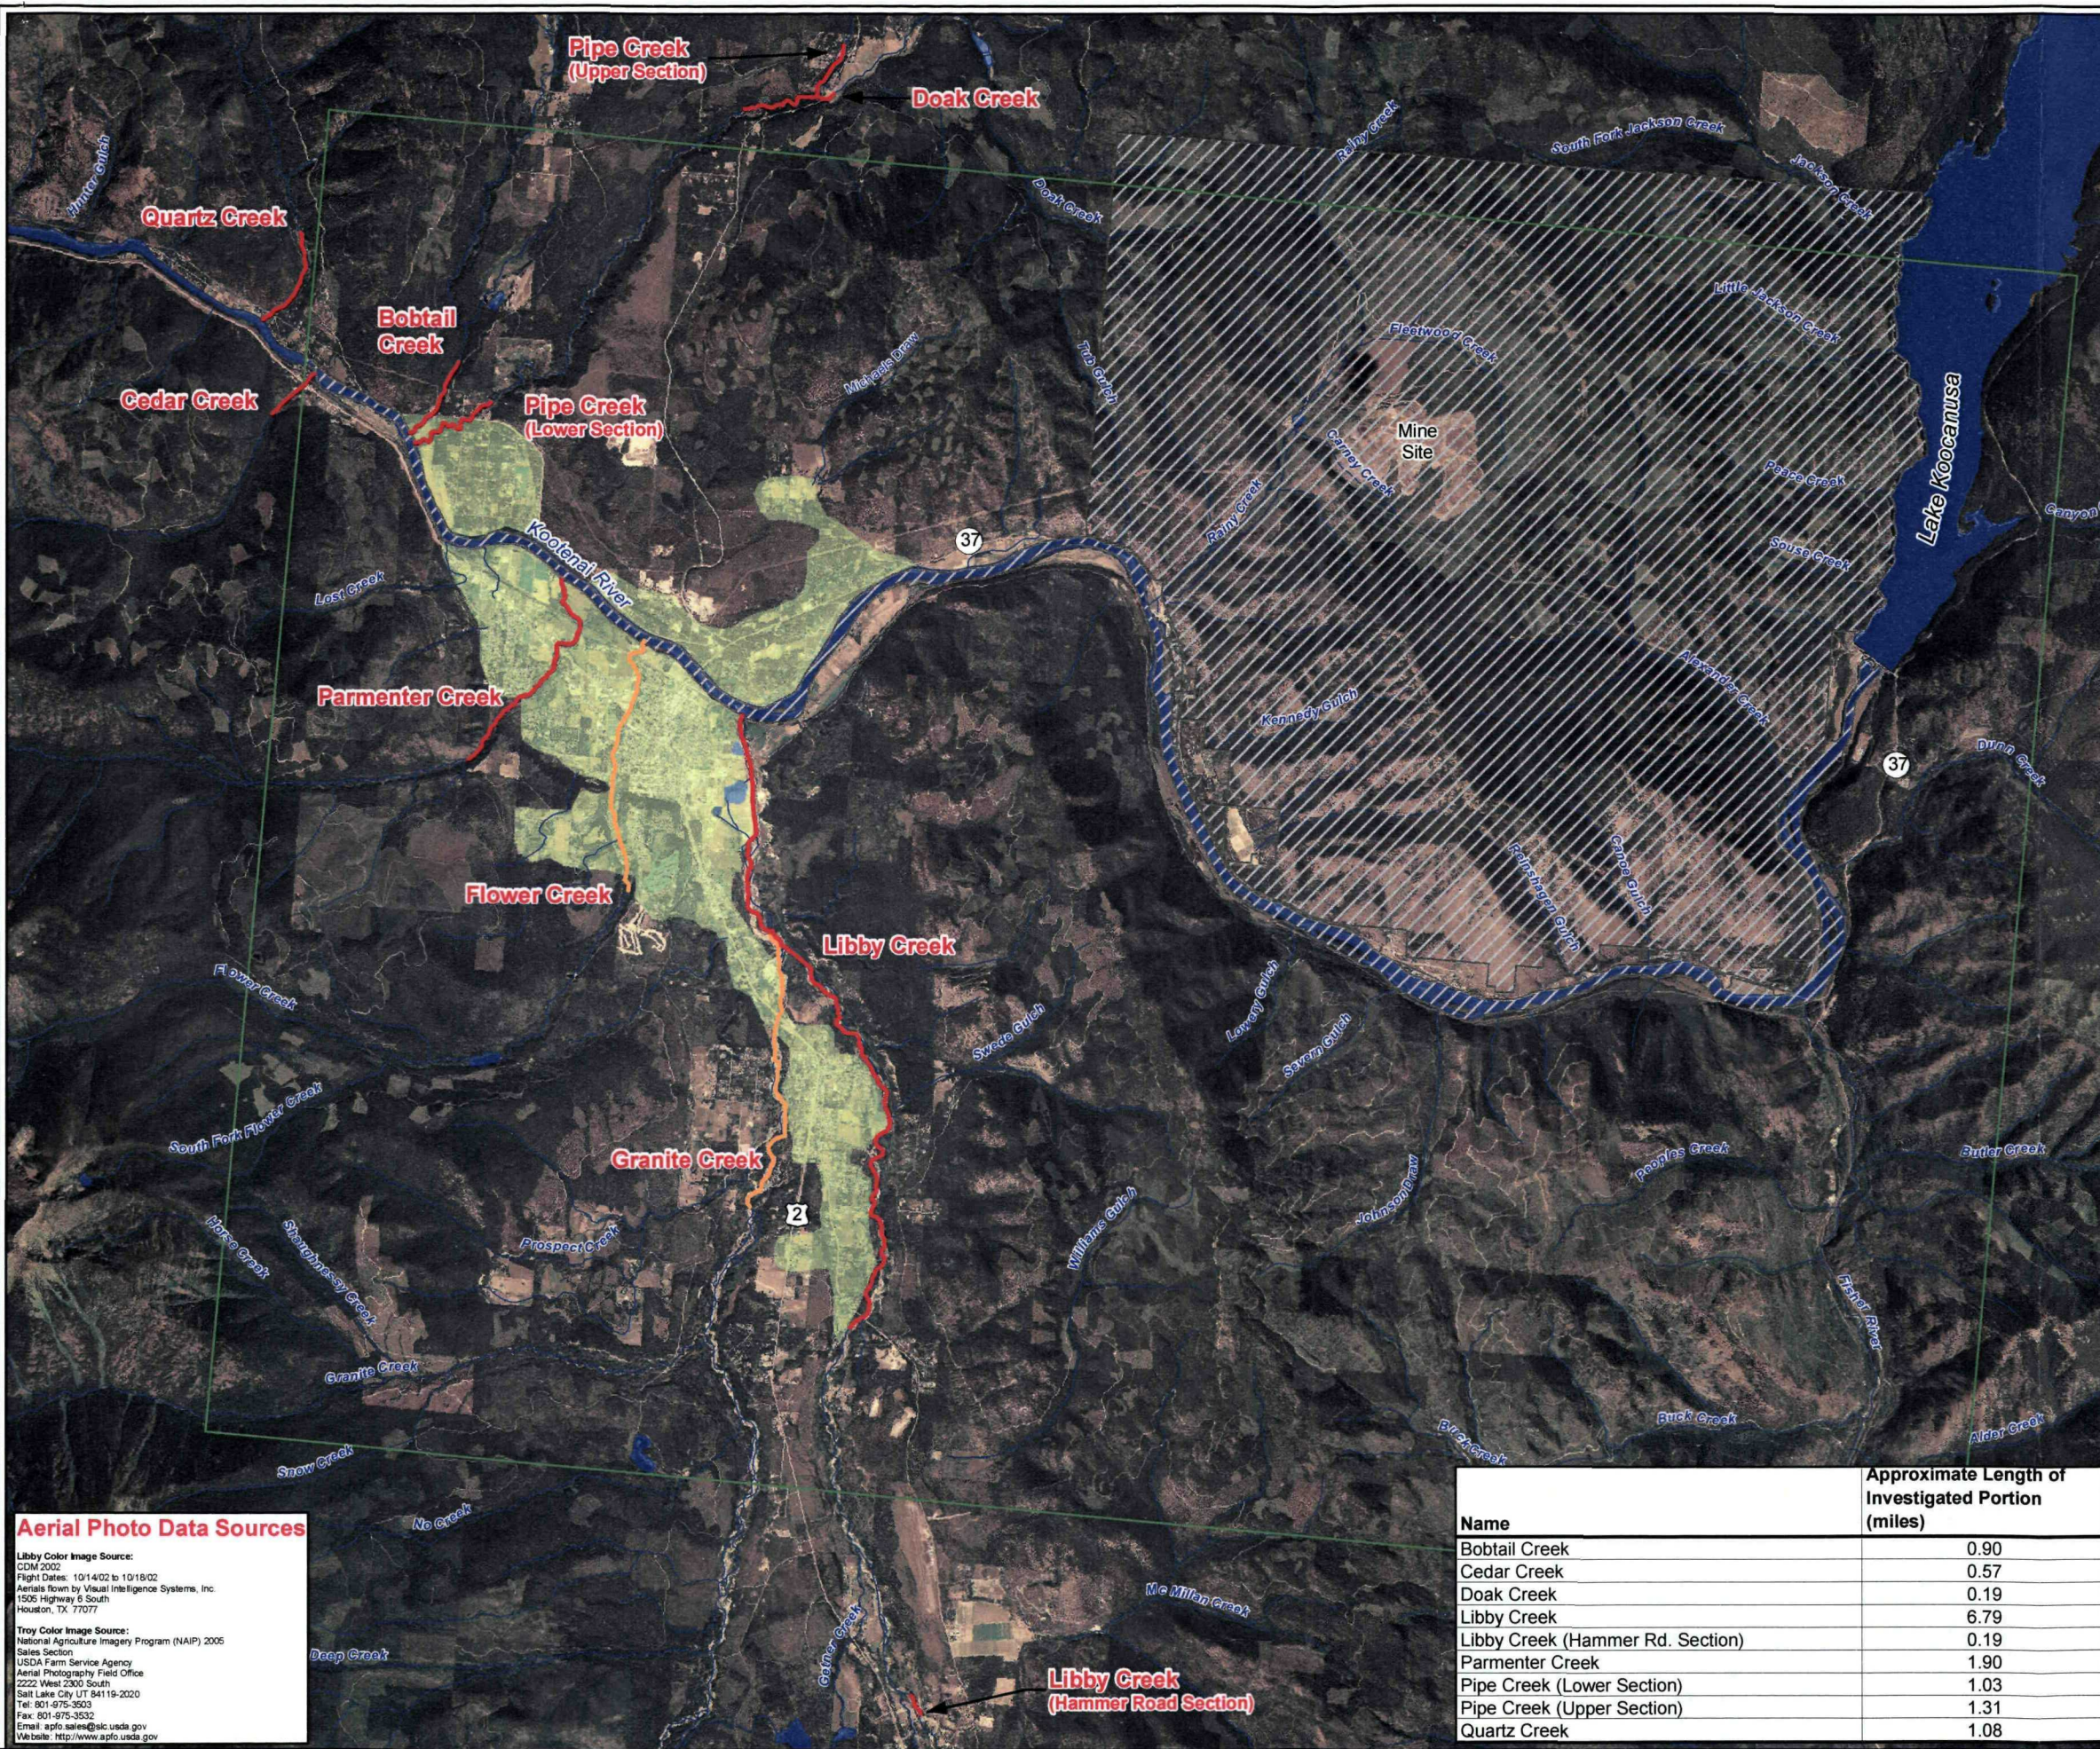
Figure 1

A 1-mile section of Pipe Cr, beginning at the Kootenai River, was investigated on October 13, 2008 (Figure 1). Riprap material in this section of Pipe Cr is composed of metasediments and basalt except for riprap located at two residential properties on the northern bank of Pipe Cr, between Kootenai River Rd and Botham Drive (Figure 3).
